Subsurface Water Distribution Mapping and Seasonal Fluctuation of Water Table Determination for Water Management at Ban Pa Sak Ngam, Luang Nuea Subdistrict, Doi Saket District, Chiang Mai Province

¹ Department of Geological Sciences, Faculty of Science, Chiang Mai University

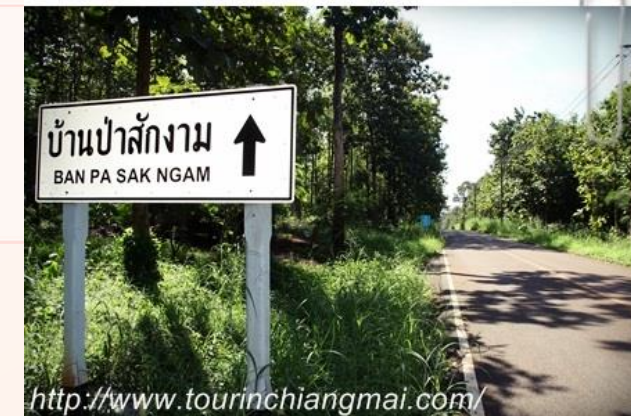
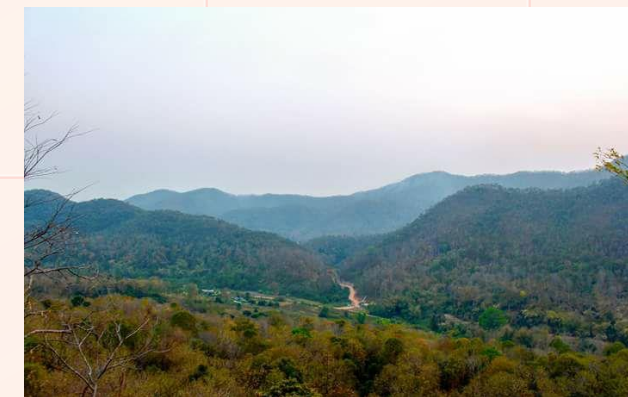
- Ban Pa Sak Ngam is situated in the northeastern part of Chiang Mai Basin, Thailand.
- The study covers the area of about 10.5 sq. km.

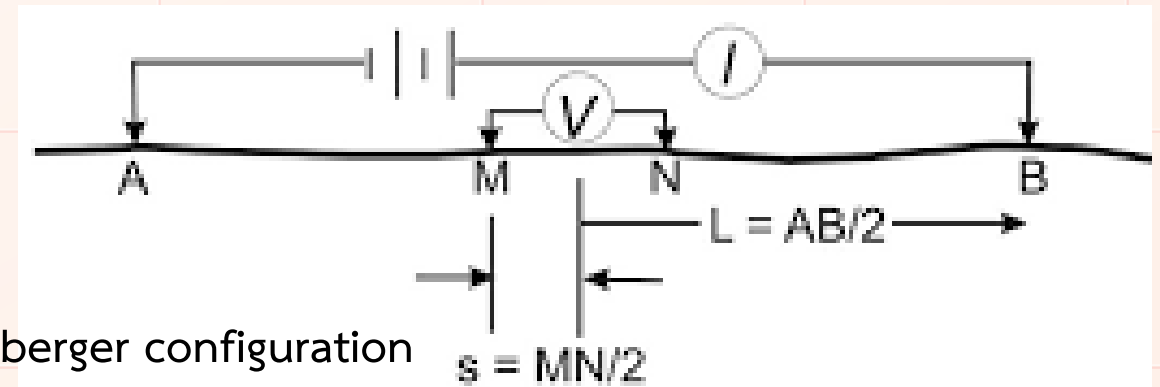
- Schlumberger configuration
- The Schlumberger configuration is an array where four electrodes are placed in-line around a common midpoint. The two outer electrodes, A and B, are current electrodes, and the two inner electrodes, M and N, are potential electrodes placed close together.

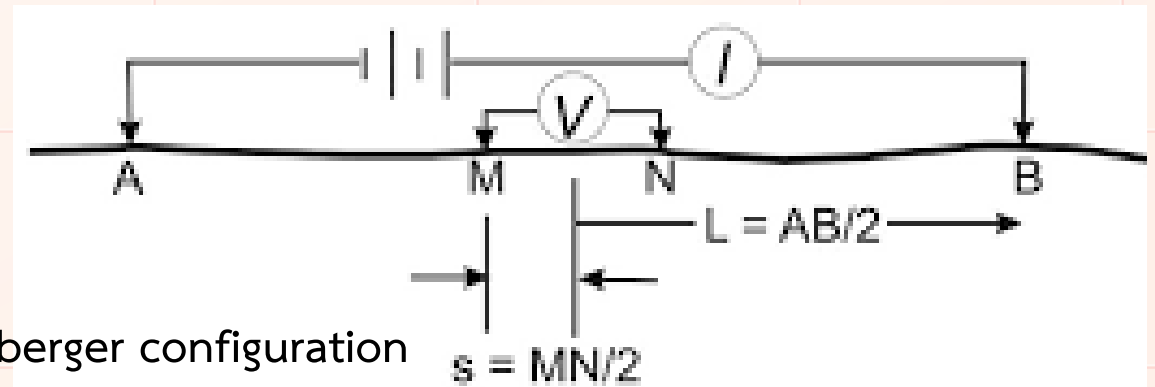
Schlumberger configuration

- For each measurement, the current electrodes, A and B, are moved outward to a greater separation throughout the survey, while the potential electrodes M and N stay in the same position until the observed voltage becomes too small to measure. At this point, the potential electrodes M and N are moved outward to a new spacing. The reasonable distance between M and N should be equal to or less than one-fifth of the distance between A and B.

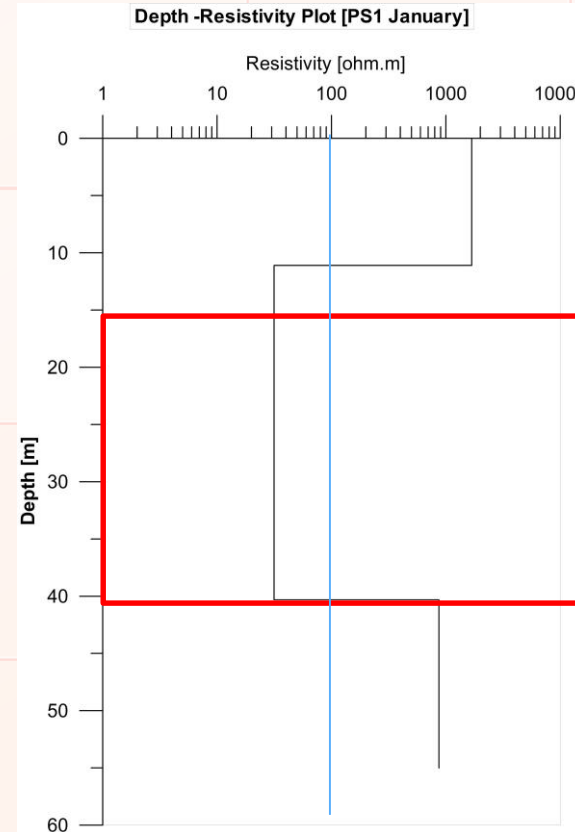
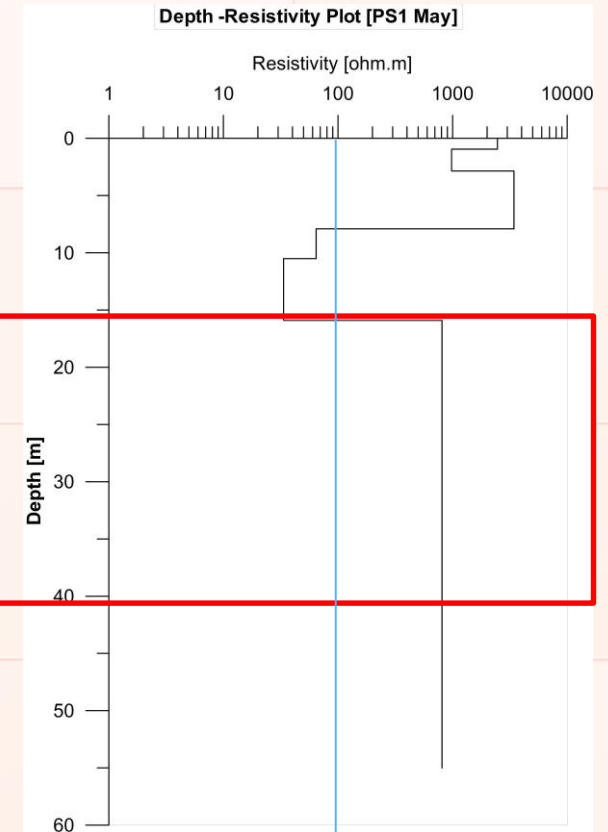
PS1 in Png1 unit

- Fracture rock can be distinguished at the depth between 15.90 m and 40.32 m
- Subsurface water level can be found at the depth of about 10 m.

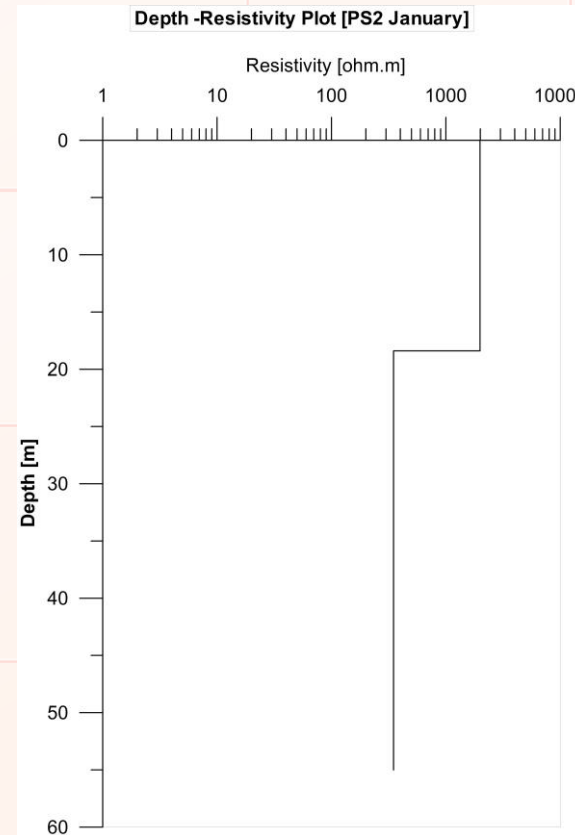
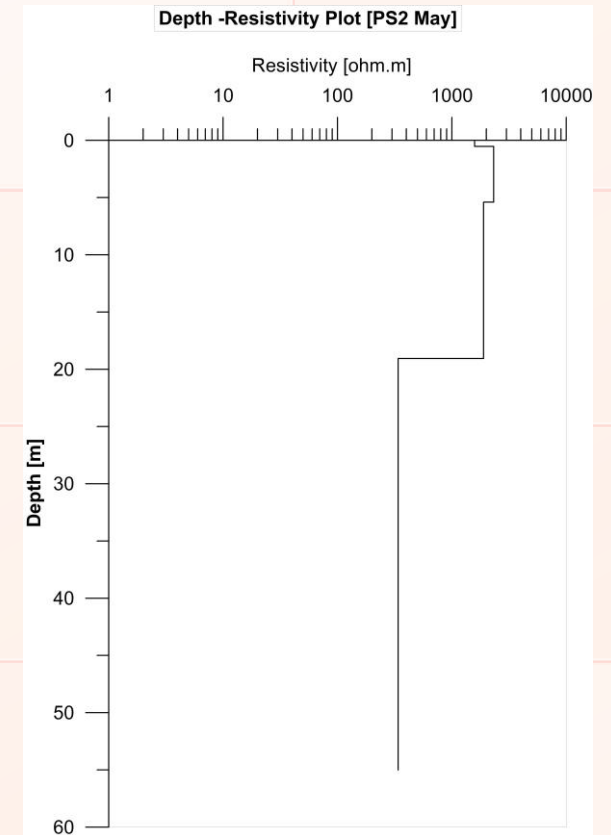
PS2 in Png1 unit

- Resistivity patterns are quite stable indicating no effect of rainfall on the subsurface water.

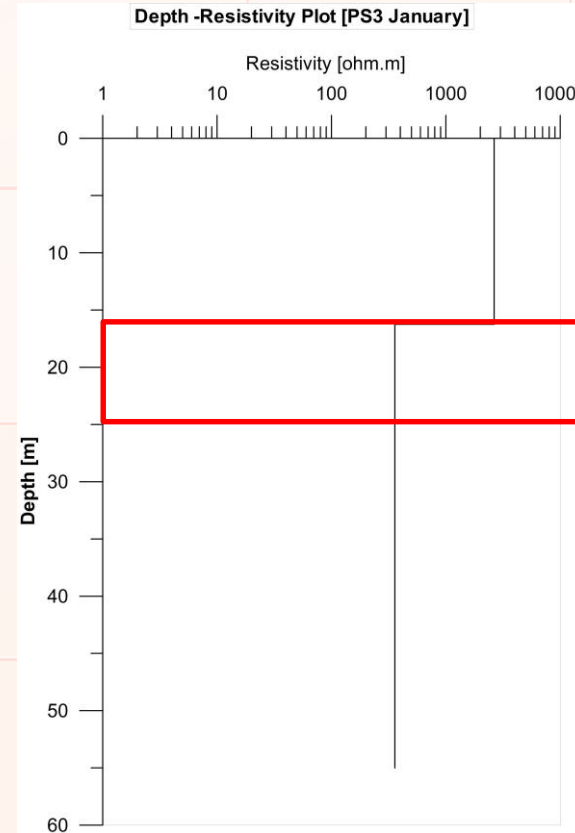
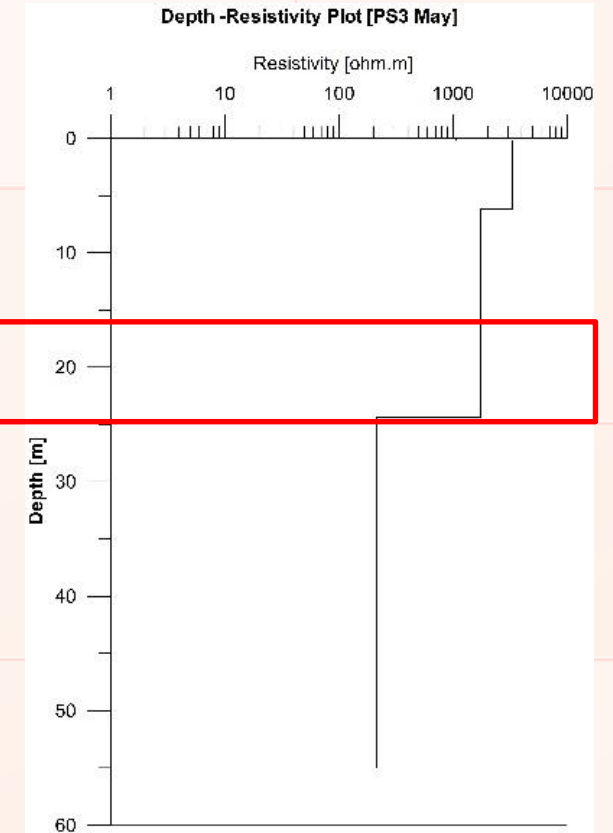
PS3 in Png1 unit

- AT the depth between 16.23 m and 24.36 m, fracture rock is indicated

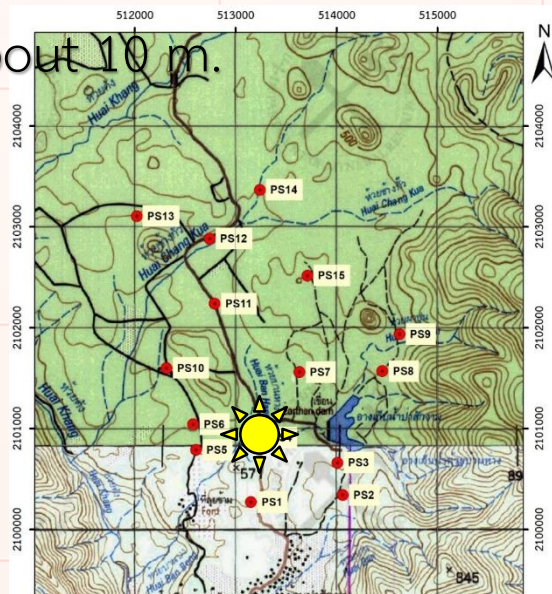
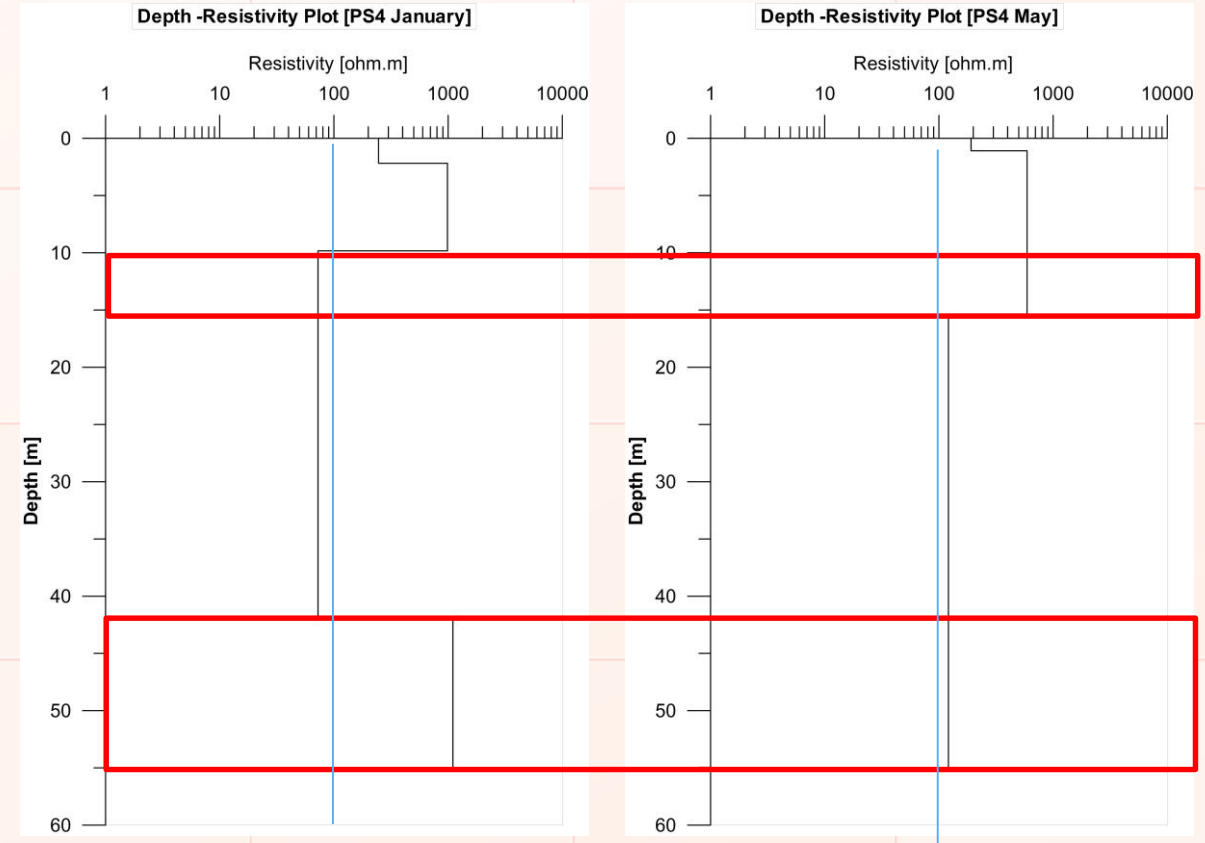
PS4 in Png1 unit

- AT the depth between 9.83 m and 15.43 m, and the depth greater than 41.97 m, fracture rock is indicated
- Subsurface water level can be found at the depth of about 10 m.

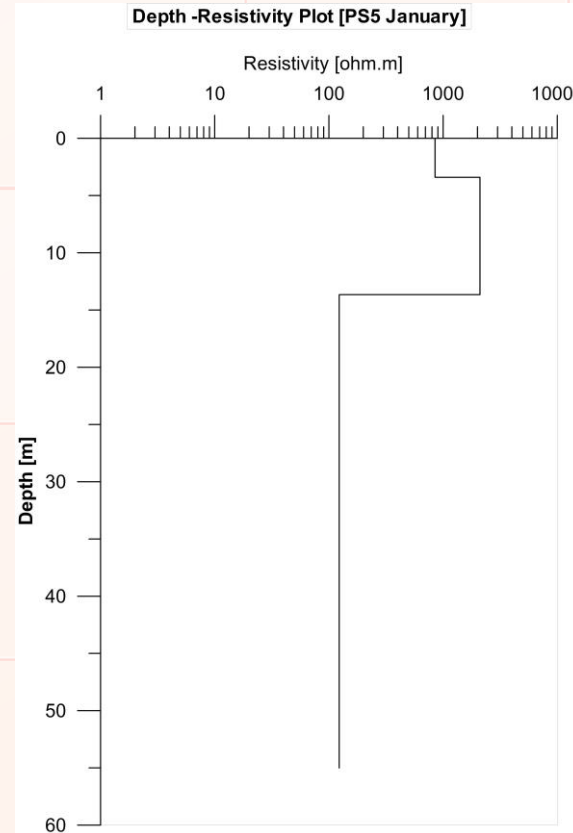
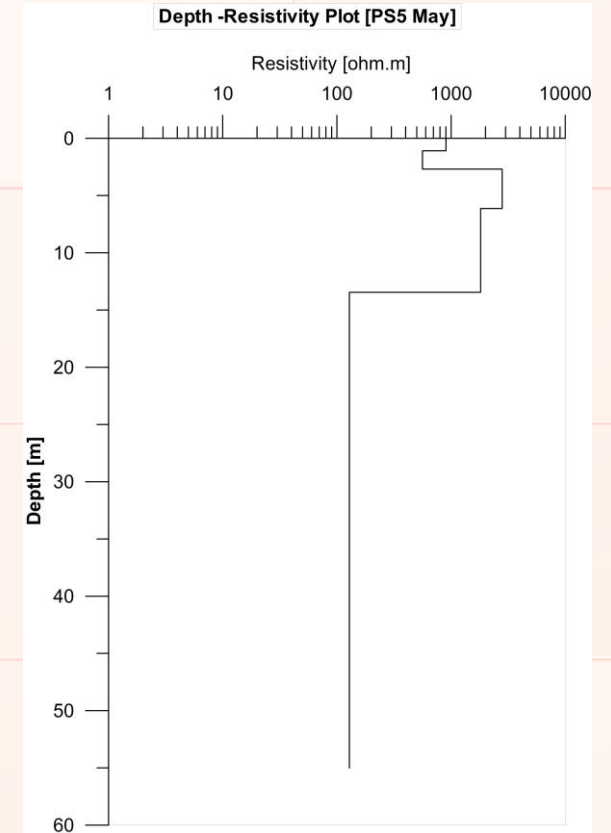
PS5 in Png1 unit

- Resistivity patterns are quite stable indicating no effect of rainfall on the subsurface water

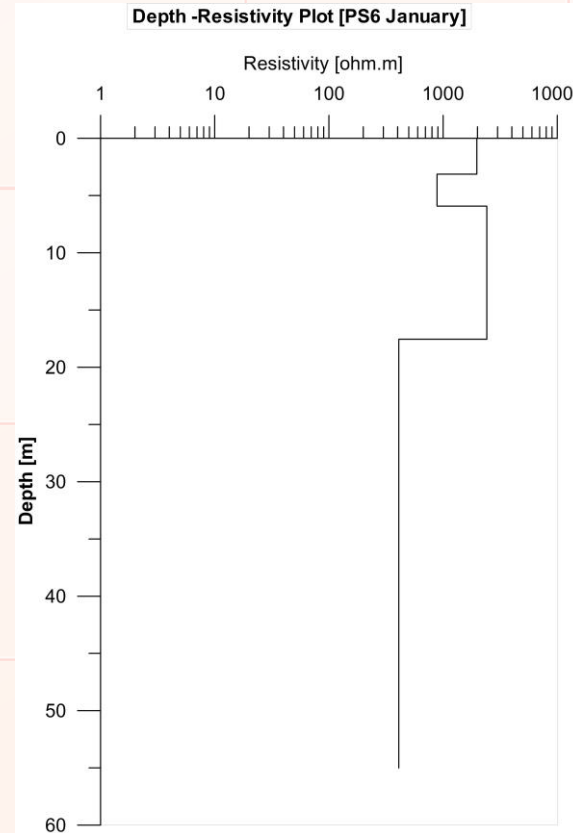
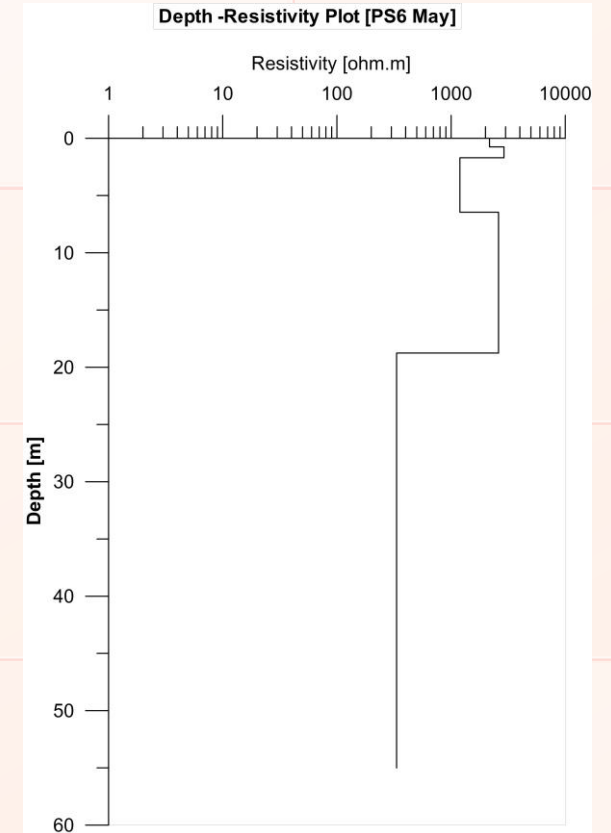
PS6 in Png2 unit

- Resistivity patterns are quite stable indicating no effect of rainfall on the subsurface water

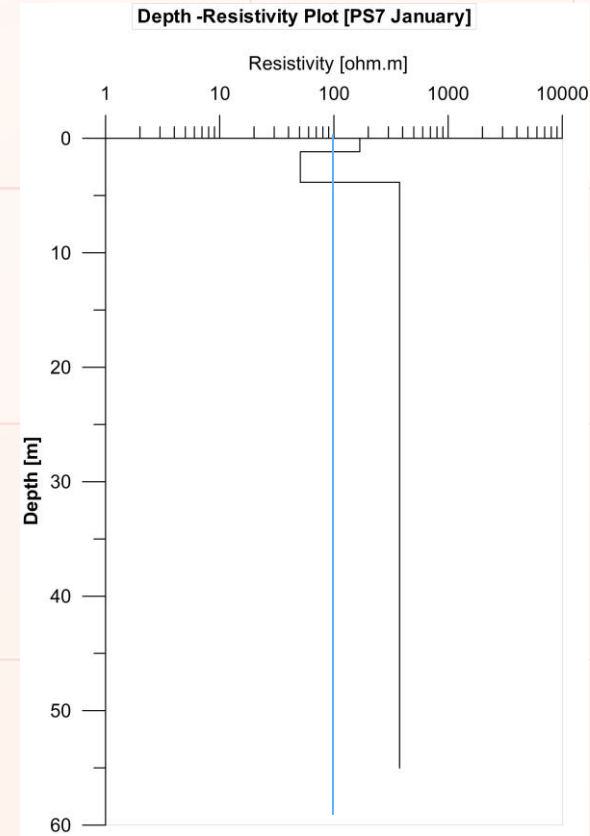
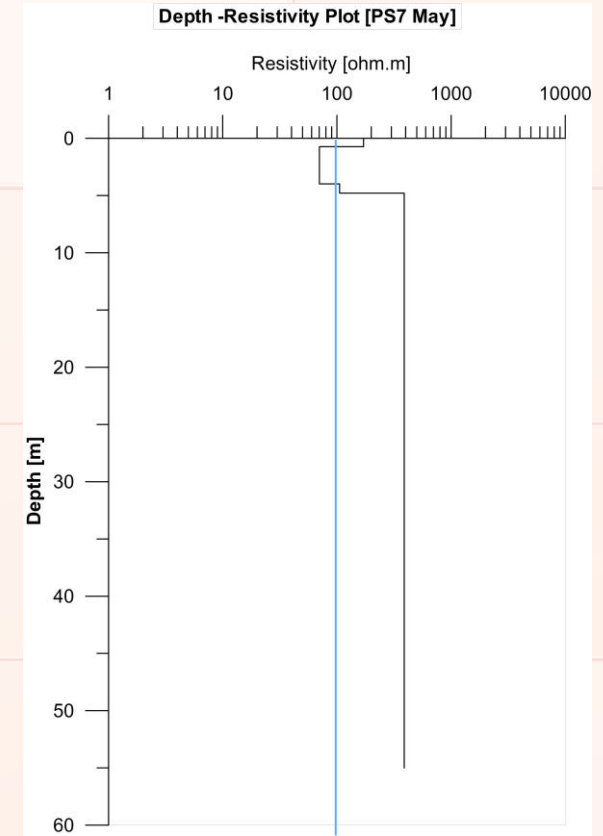
PS7 in Png1 unit

- Resistivity patterns are quite stable indicating no effect of rainfall on the subsurface water
- Subsurface water level can be found at the depth of about 1 m

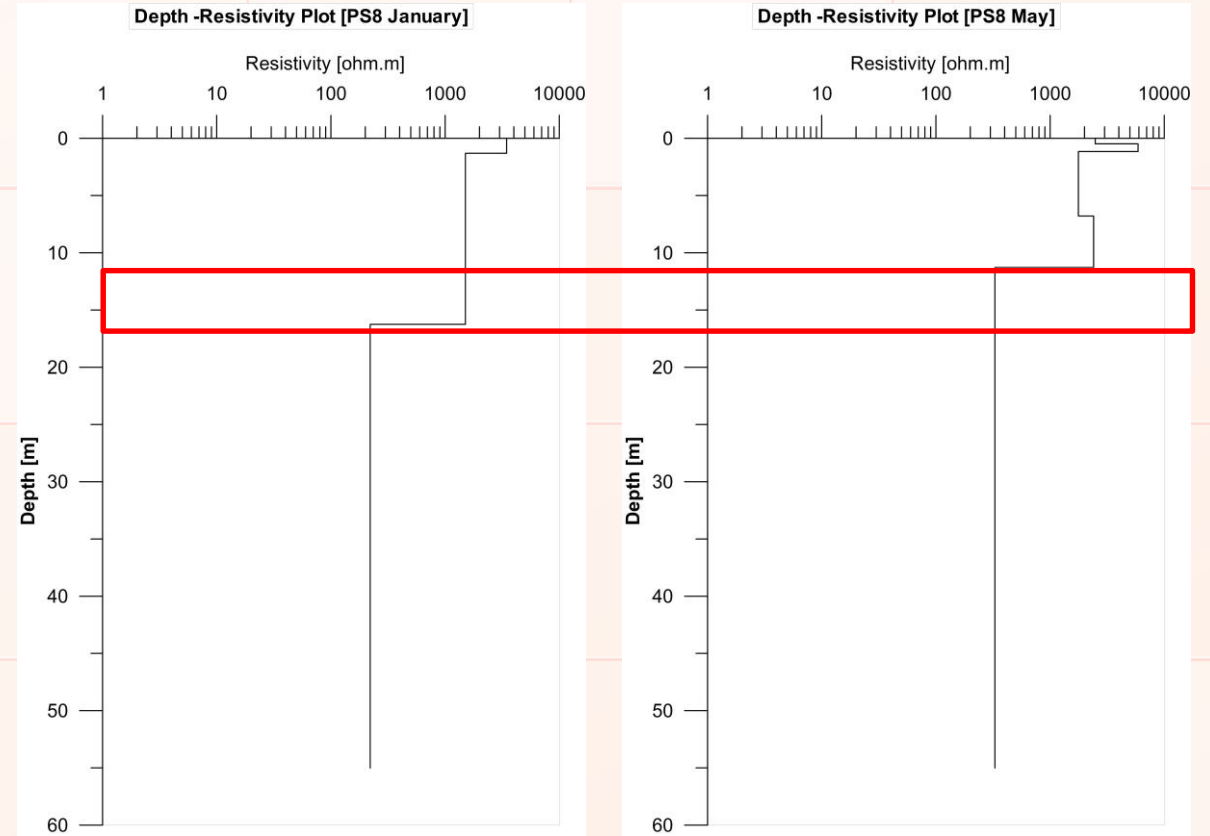
PS8 in Png1 unit

- AT the depth between 11.29 m and 16.25 m, fracture rock is indicated

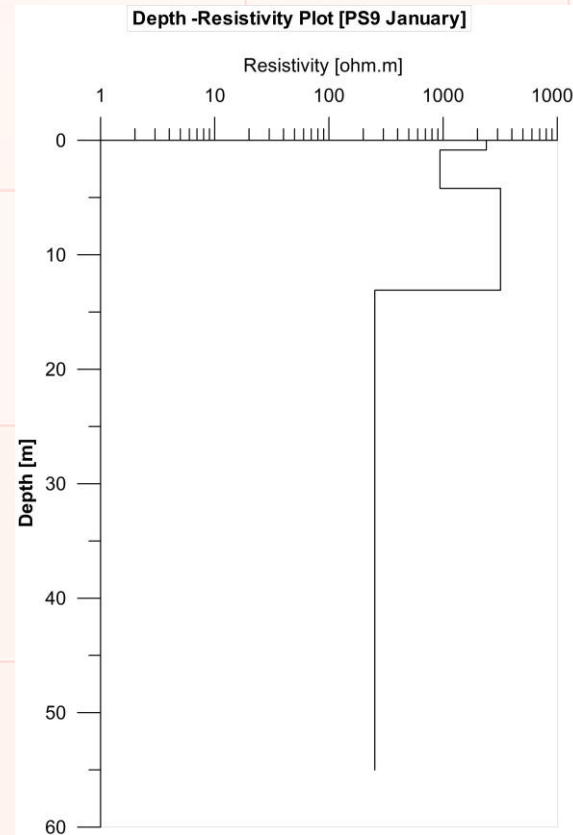
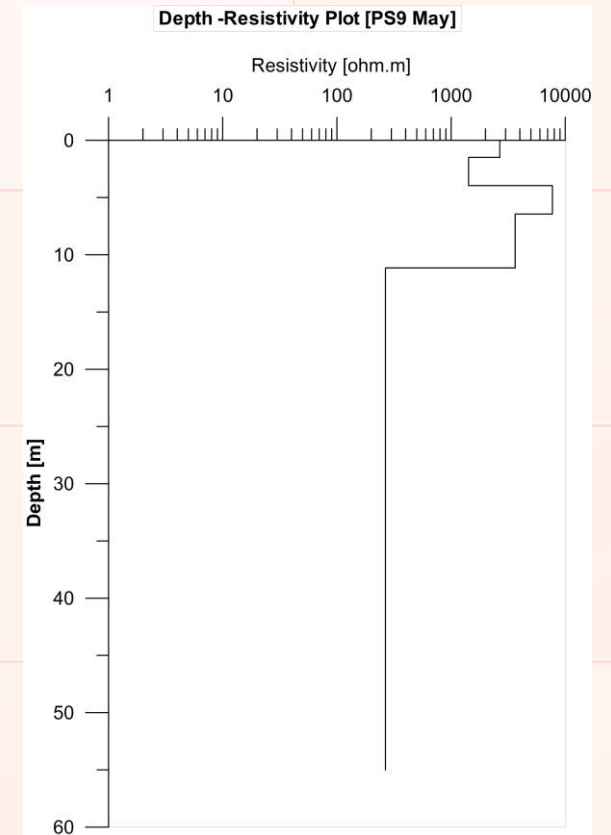
PS9 in Png1 unit

- Resistivity patterns are quite stable indicating no effect of rainfall on the subsurface water

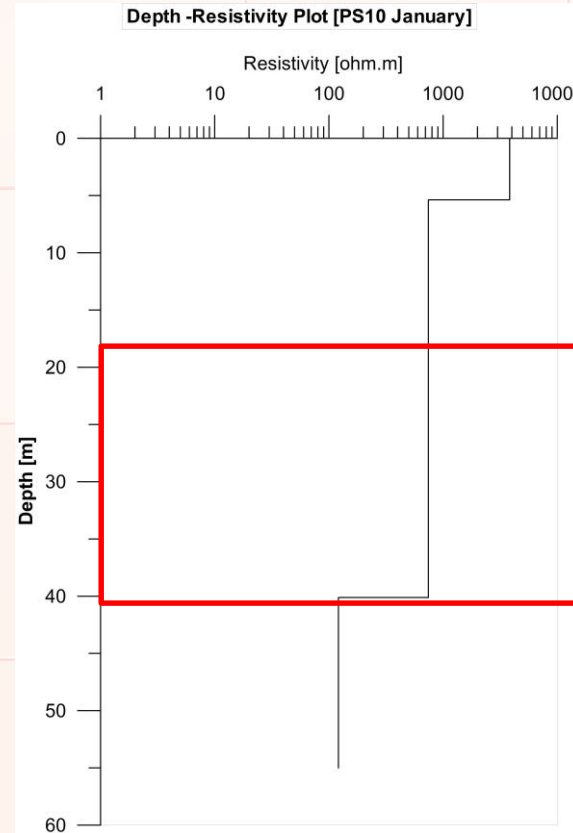
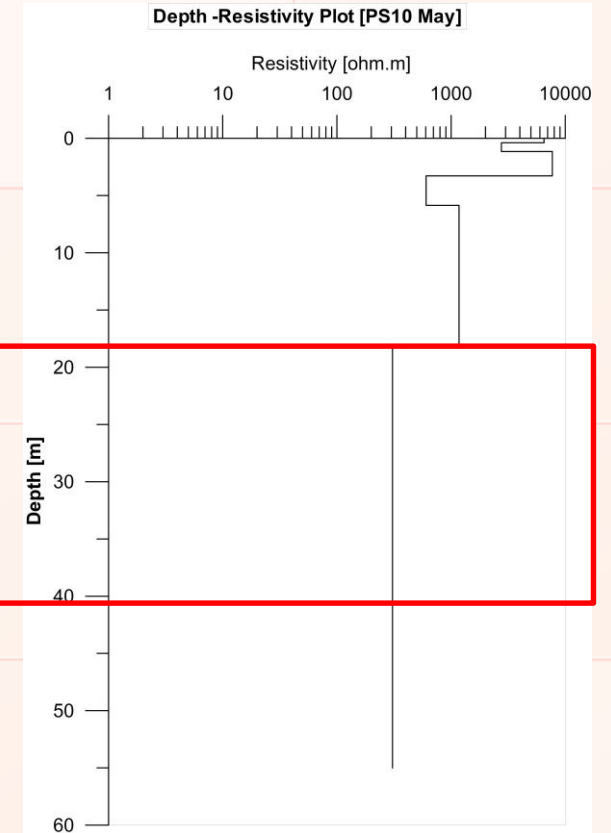
PS10 in Png2 unit

- AT the depth between 18.18 m and 40.11 m, fracture rock is indicated.

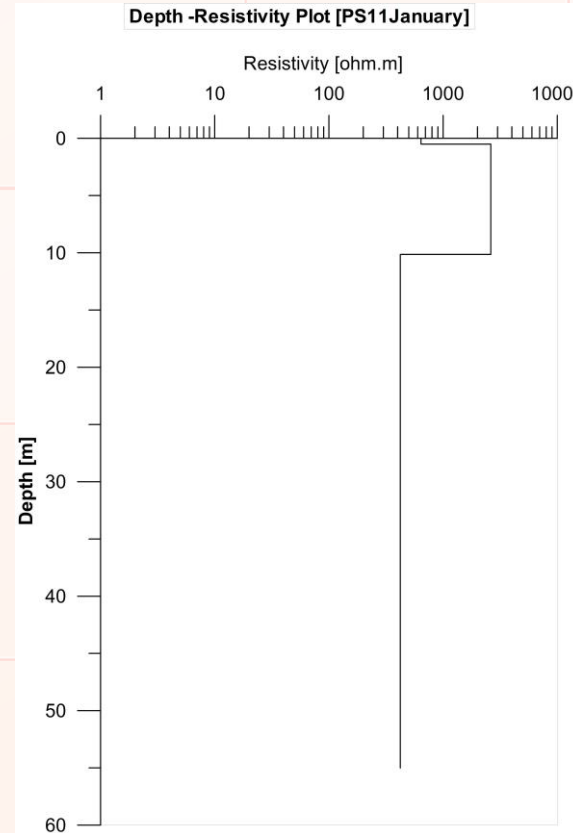
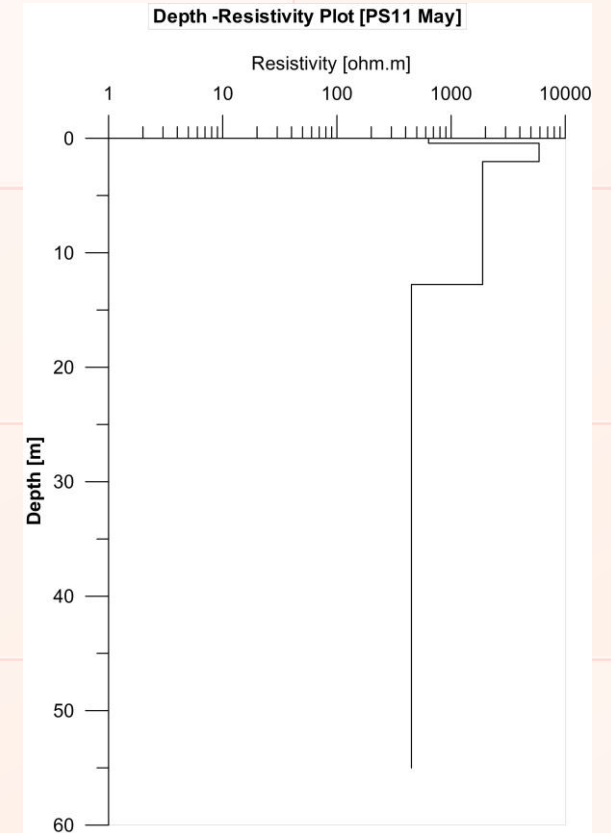
PS11 in Png2 unit

- Resistivity patterns are quite stable indicating no effect of rainfall on the subsurface water.

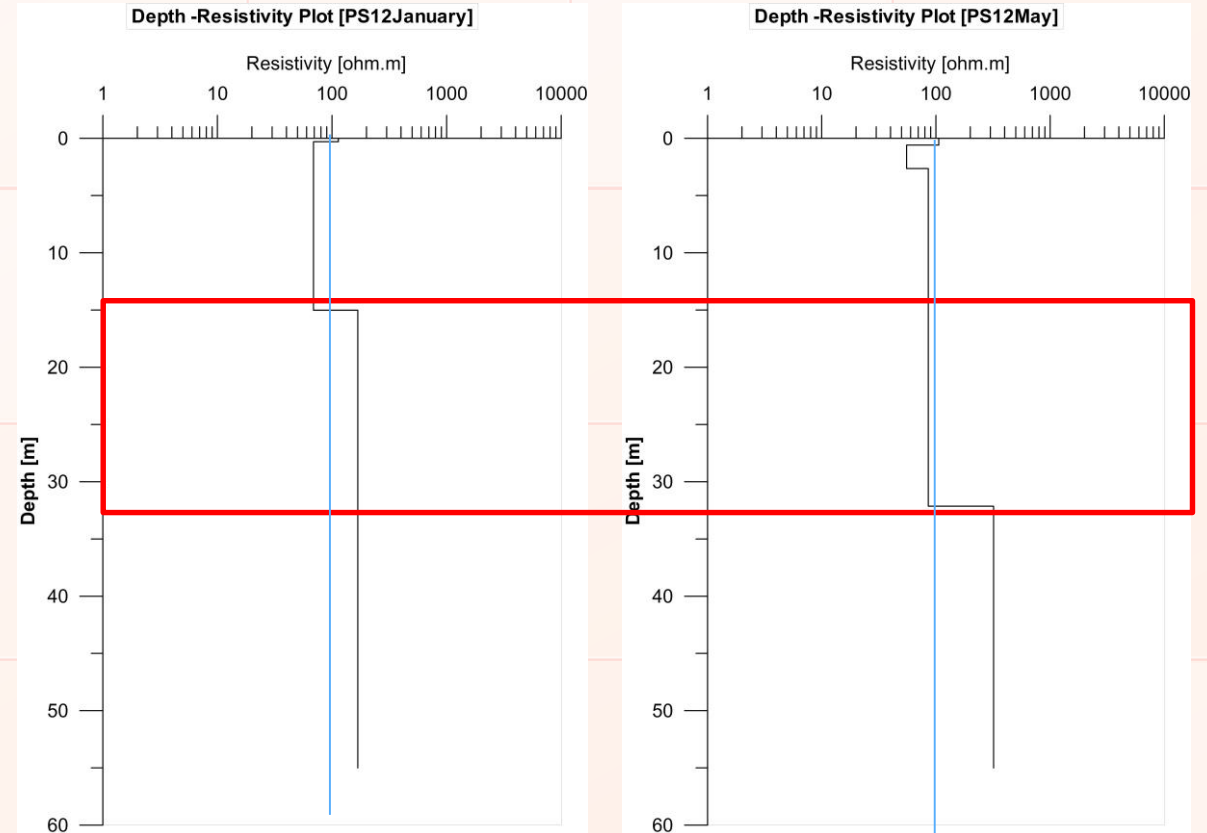
PS12 in Png1 unit

- AT the depth between 15.02 m and 32.14 m, fracture rock is indicated.
- Subsurface water level can be found at the depth of about 0.4 m.

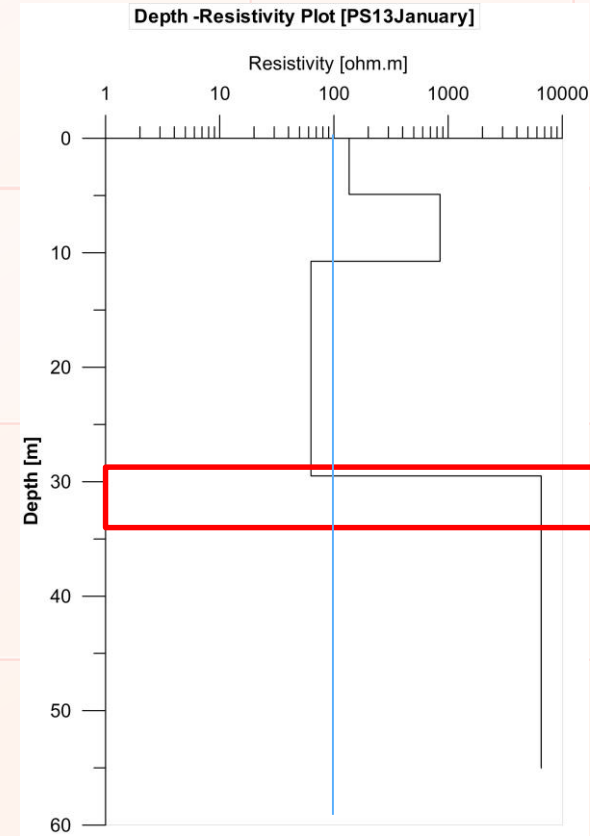
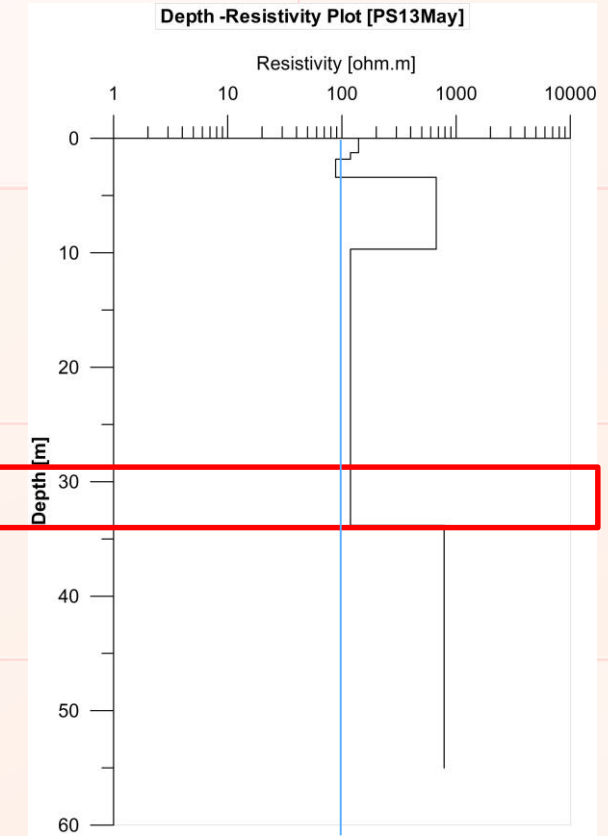
PS13 in Png2 unit

- AT the depth between 29.49 m and 33.84 m, fracture rock is indicated.
- Subsurface water level can be found at the depth of about 10 m.

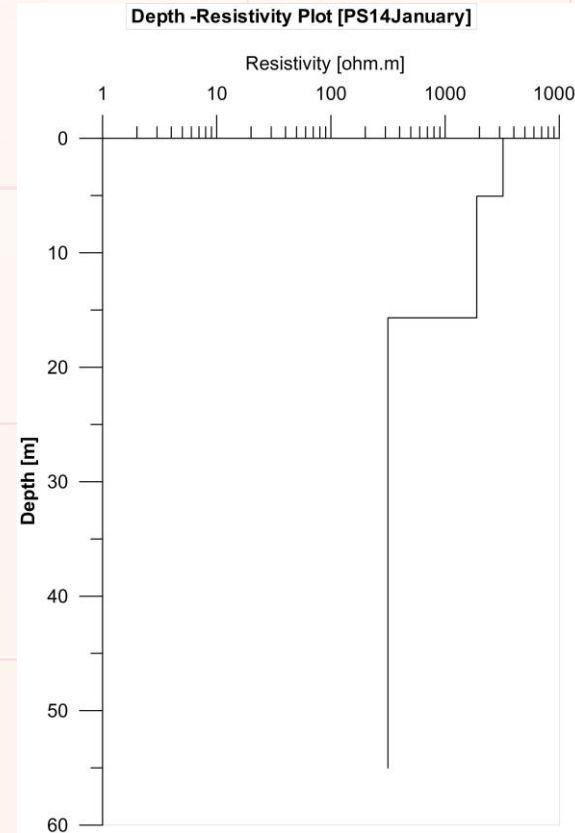
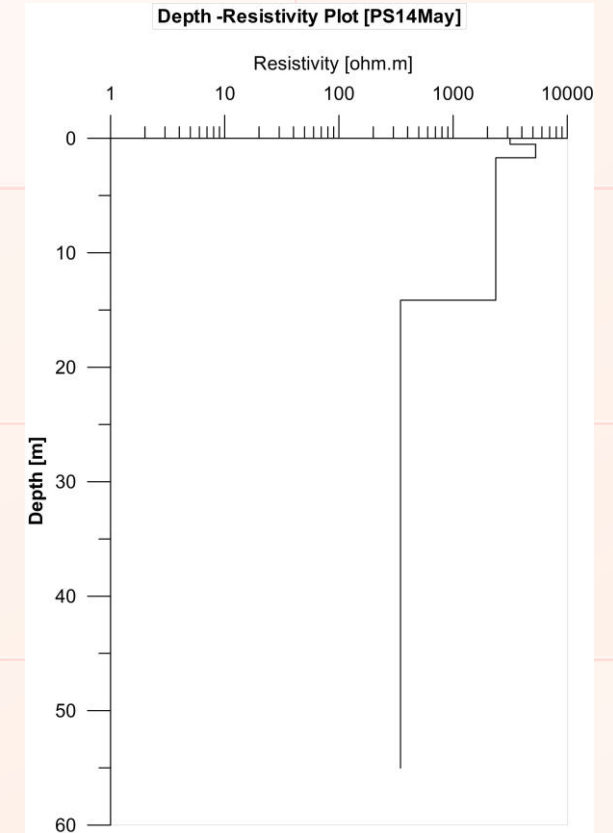
PS14 in Png1 unit

- Resistivity patterns are quite stable indicating no effect of rainfall on the subsurface water

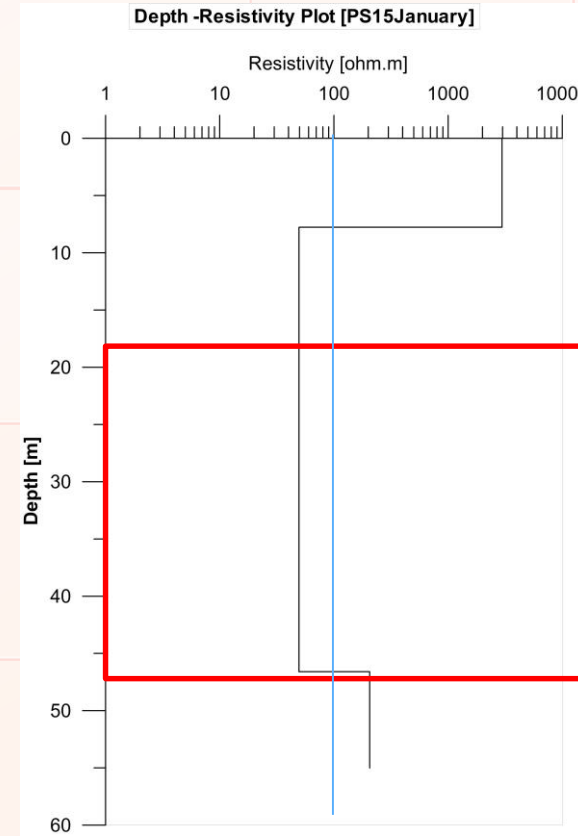
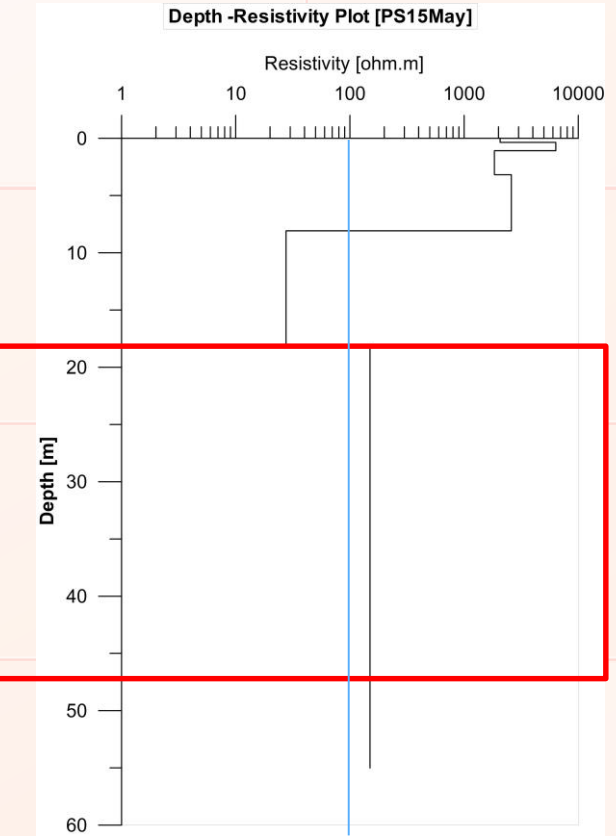
PS15 in Png1 unit

- AT the depth between 18.22 m and 46.6 m, fracture rock is indicated
- Subsurface water level can be found at the depth of about 9 m.

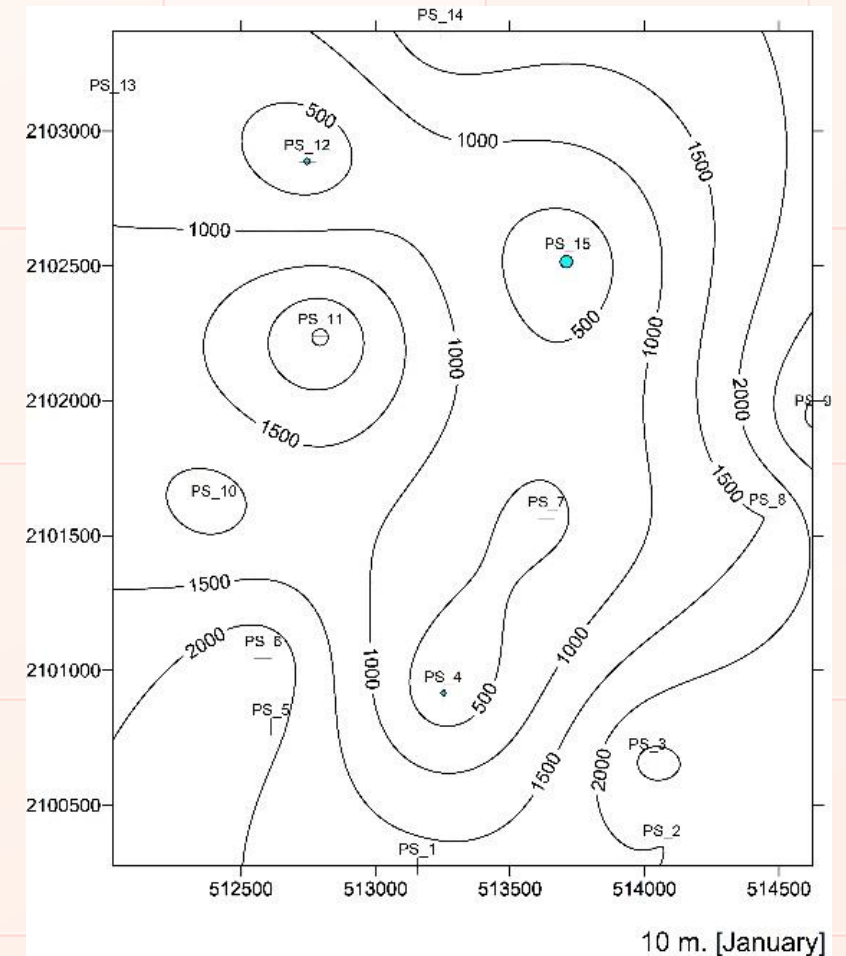
- 10 m [January]
- Resistivity contour map at the depth of 10 m., **three** small areas (around PS4, PS12 and PS15) show resistivity value less than 100 ohm.m.

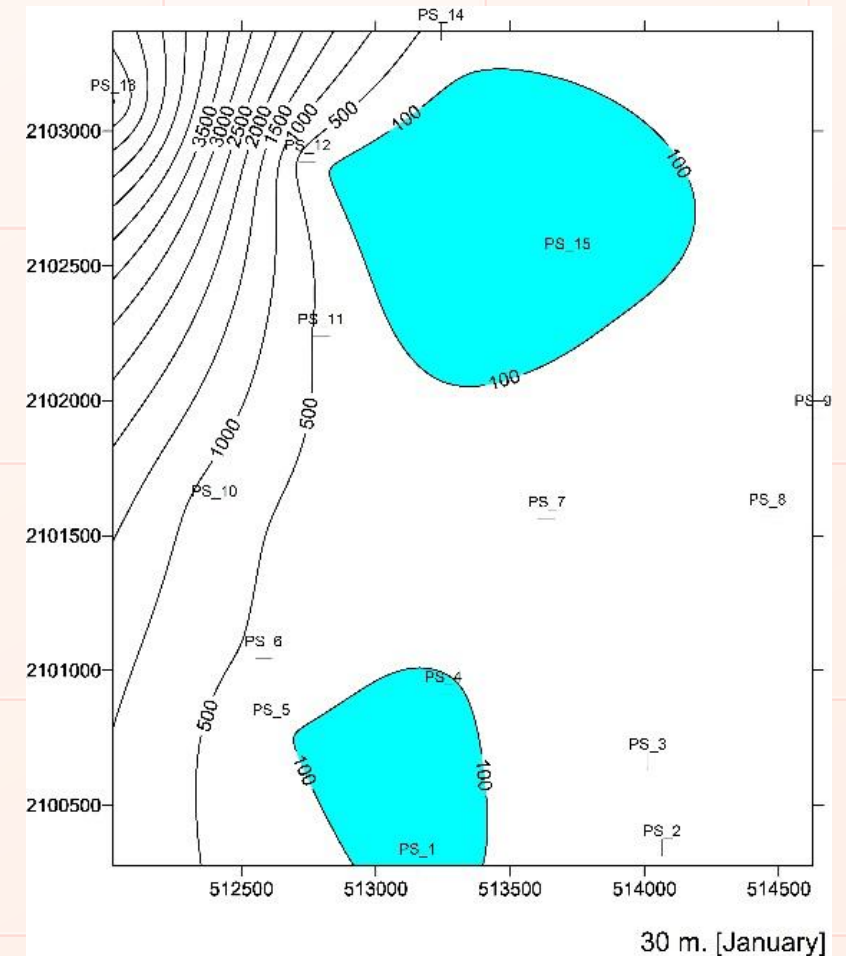
- 30 m [January]
- Resistivity contour map at the depth of 30 m., **two** areas show the resistivity value equal or less than 100 ohm.m.

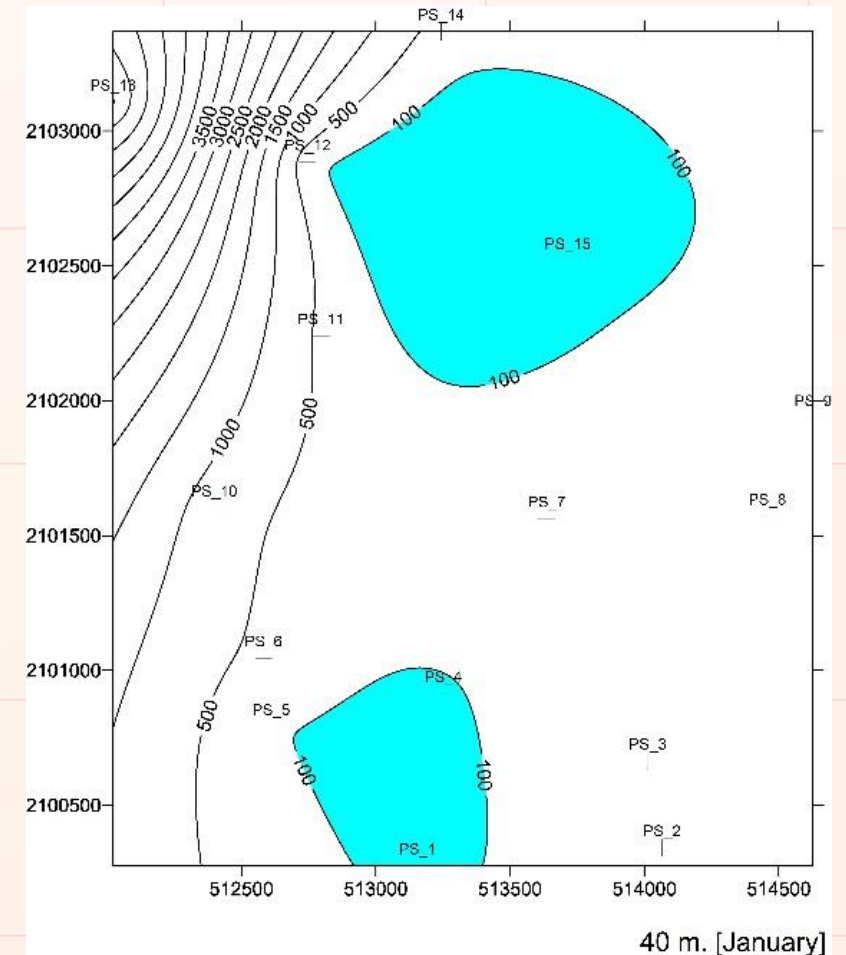
- 40 m [January]
- Resistivity contour map at the depth of 40 m., **two** areas show the resistivity value equal or less than 100 ohm.m.

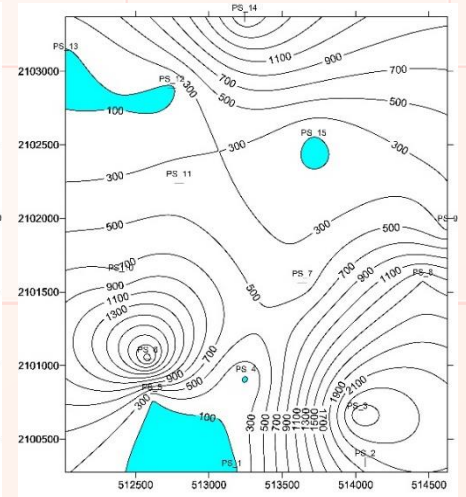
- [January]
- Two levels of subsurface were detected.

- Fracture rocks can be found in both Png1 and Png2 units
- Data collected in January showed the subsurface water at **one** level of the shallow depth (**15 m**) in the **north-western**, **north-eastern**, and **southern** parts of the study area, and **one** level of the deep depth (> 30 m) in the northern and southern parts of the study area.
- Data collected in May showed the subsurface water at **one** level at the shallow depth (**15 m**) in the **north-western**, **north-eastern**, and **southern** parts of the study area.

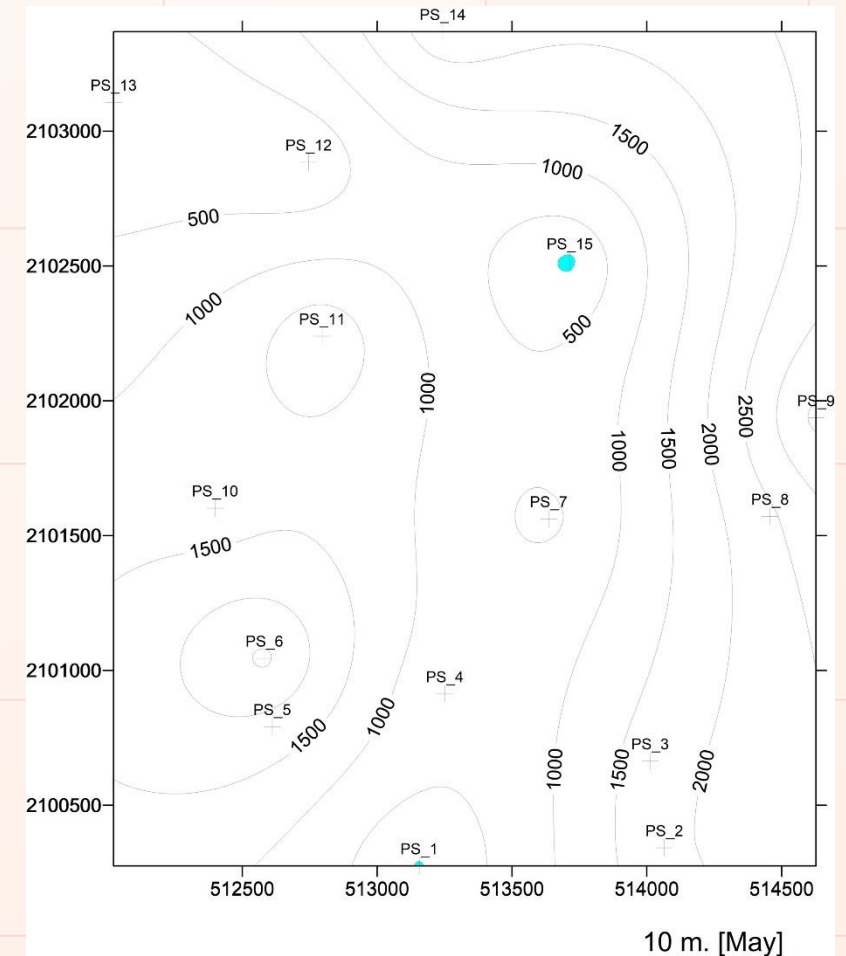
- 10 m [May]
- Resistivity contour map at the depth of 10 m., **two** small (PS1 and PS15) areas show the resistivity value equal or less than 100 ohm.m.

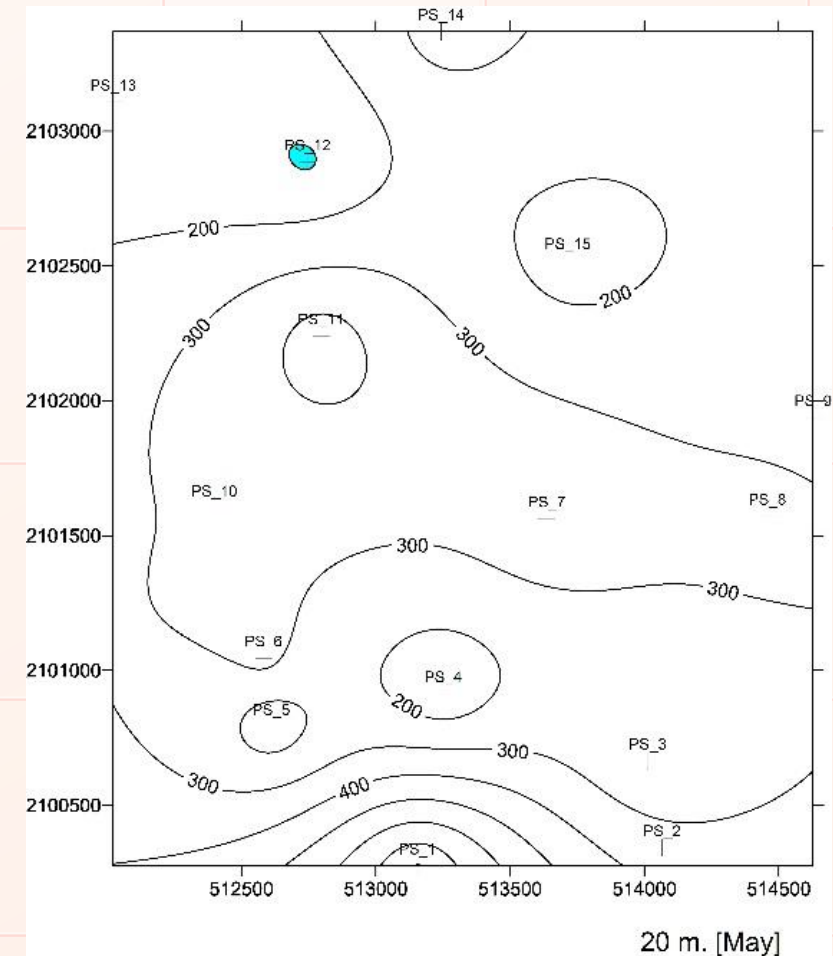
- 20 m [May]
- Resistivity contour map at the depth of 20 m., **one** small area (PS12) shows the resistivity value equal or less than 100 ohm.m.

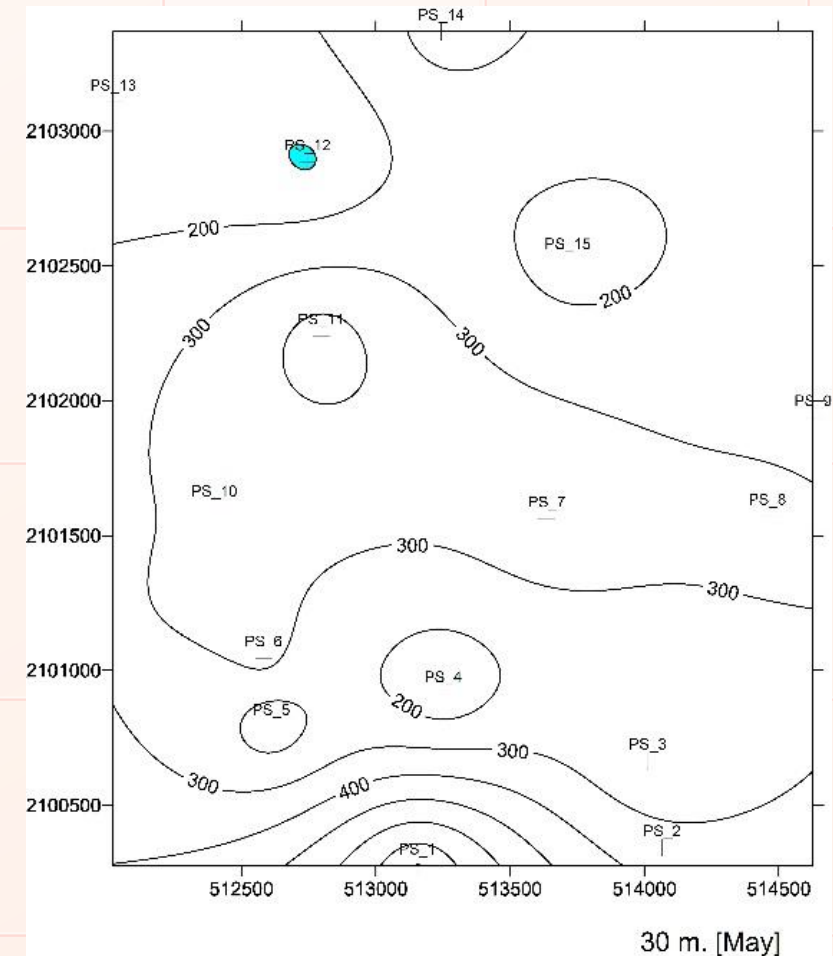
- 30 m [May]
- Resistivity contour map at the depth of 30 m., **one** small area (PS12) shows the resistivity value equal or less than 100 ohm.m.
